Application News

No. A509

Analysis of Tapwater Contaminants by FTIR and EDX Spectroscopy

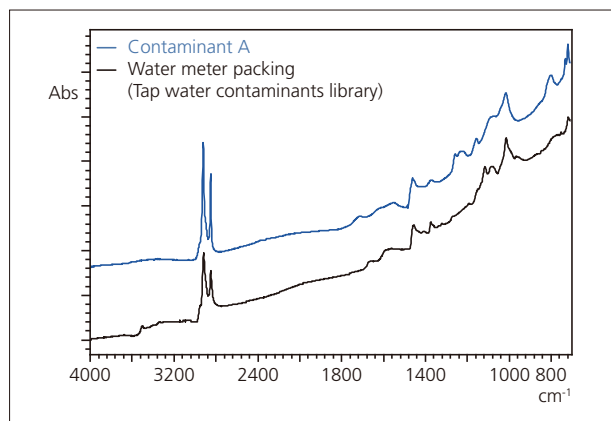
Fig. 2 ATR Spectra of Contaminant A and Spectra Search Result

The contaminant was collected and examined by single-reflection attenuated total reflection (ATR) measurement. The ATR spectrum we obtained and spectra search results are shown in Fig. 2. The ATR spectra matches an entry in the tap water contaminant library, based on which the contaminant is inferred to be an ethylene propylene diene rubber (EPDM) with additives that include talc and kaolin.

Library Information for Water Meter Packing

Materials: Ethylene propylene diene rubber (EPDM), magnesium silicate (TALC), aluminum silicate (KAOLIN).
Major elements: Si, Mg Color: Black Shape: Rubber/fragment
Hardness: Soft Metallic luster: No Technique: ATR (Ge)

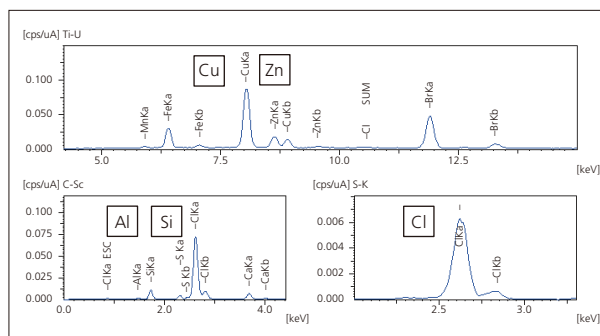
Fig. 3 Qualitative and Quantitative Results for Contaminant A Obtained by EDX Analysis

Results of qualitative and quantitative analysis of ⁶C-⁹²U are shown in Fig. 3. Based on the results of FTIR analysis, EPDM (C₅H₁₀) was used as the balance¹⁾. Si and Al come from talc and kaolin, which corroborates the data obtained by FTIR analysis. Cl is present in chlorine used in tap water, and metallic elements such as Cu and Zn are presumed to come from elution and deposition of water supply parts.

Constituent	Cl	Si	Al	Ca	S	Cu
Quantitative value (%)	1.48	0.57	0.19	0.10	0.070	0.021

Constituent	Fe	Br	Zn	Mn	C ₅ H ₁₀
Quantitative value (%)	0.013	0.007	0.003	0.001	97.6

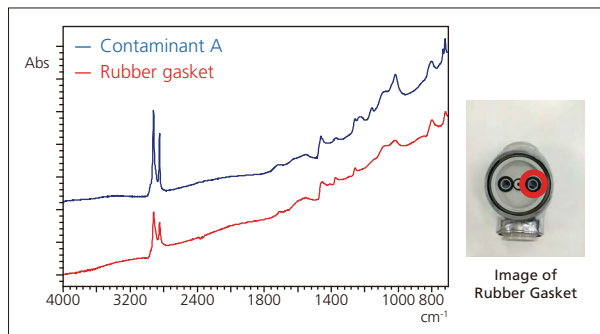
Fig. 4 ATR Spectra of Contaminant A and Rubber Gasket

The shower head was disassembled further and the filter and other parts analyzed by FTIR spectroscopy. The spectra obtained for Contaminant A showed similarities to the spectra obtained from a rubber gasket. The ATR spectra obtained are shown in Fig. 4. Contaminant A was identified as a fragment of this rubber gasket that had attached itself to the inside of the shower head.

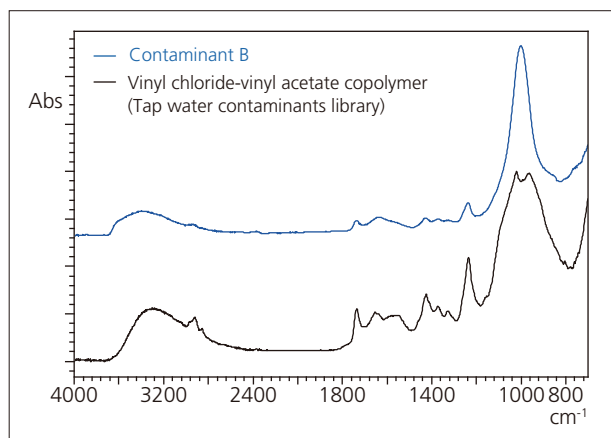
Fig. 6 ATR Spectra of Contaminant B and Spectra Search Result

The contaminant was collected and examined by single-reflection attenuated total reflection (ATR) measurement. The ATR spectrum we obtained and spectra search results are shown in Fig. 6. The ATR spectrum matched the tap water contaminants library data entry, and based on this was presumed to be a vinyl chloride-vinyl acetate copolymer.

Library Information for Vinyl Chloride-Vinyl Acetate Copolymer

Materials: Vinyl chloride-vinyl acetate copolymer
Major elements: Cl, Fe Color: Brown Shape: Splinter
Hardness: Soft Metallic luster: No Technique: ATR (Ge)

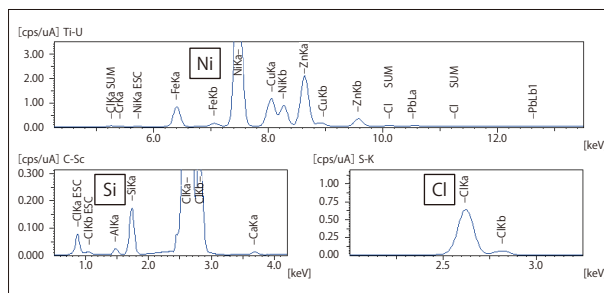
Fig. 7 Qualitative and Quantitative Results for Contaminant B Obtained by EDX Analysis

Results of qualitative and quantitative analysis of ^{60}Co - ^{92}U are shown in Fig. 7. Based on the results of FTIR analysis, vinyl acetate ($\text{C}_4\text{H}_6\text{O}_2$) was chosen as the balance, the Cl detected was considered to be from vinyl chloride ($\text{C}_2\text{H}_3\text{Cl}$), and other elements were quantified as metals. Ni was presumed to come from elution and deposition of metal plating inside the tap water outlet over a long period of time, while other elements came from supply piping and other components or from water scale.

Constituent	$\text{C}_2\text{H}_3\text{Cl}$	Si	Ni	Al	Zn	Fe
Quantitative value (%)	56.4	1.63	1.22	0.43	0.34	0.23

Constituent	Cu	Ca	Cr	Pb	$\text{C}_4\text{H}_6\text{O}_2$
Quantitative value (%)	0.20	0.13	0.010	0.006	39.4

Water supply pipes are made from vinyl chloride, while vinyl chloride-vinyl acetate copolymers are commonly used as seal materials at connection points. Contaminant B is presumed to be a piece of this seal material that has flaked off into the water due to degradation occurring over time. No parts around the tap water outlet were found that matched the constituents of Contaminant B.
