Deterioration Analysis of Automobile Headlight Cover by Plastic Analyzer

This article introduces an example of an analysis of an automobile headlight cover using Plastic Analyzer.

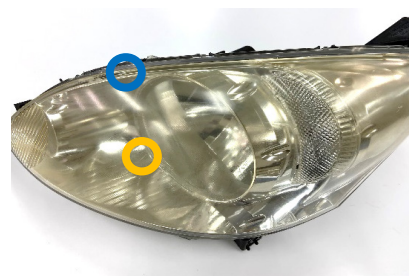
An automotive headlight cover was analyzed. Fig.2 shows a photograph of the measurement specimen. In Fig.2, discoloration or other deterioration of the specimen appearance cannot be seen at the position shown by the blue circle (this position is called the “transparent part”), whereas discoloration due to outdoor exposure can be confirmed at the position indicated by the yellow circle (“yellowed part”), which is near the center of the headlight cover. After cutting out the transparent part by the knife at the edge of the headlight cover and the yellowed part at the center, the surfaces that had been exposed outdoors were analyzed by the ATR method.

Fig. 2 Measurement Specimen
(Yellow Circle: Yellowed Part, Blue Circle: Transparent Part)

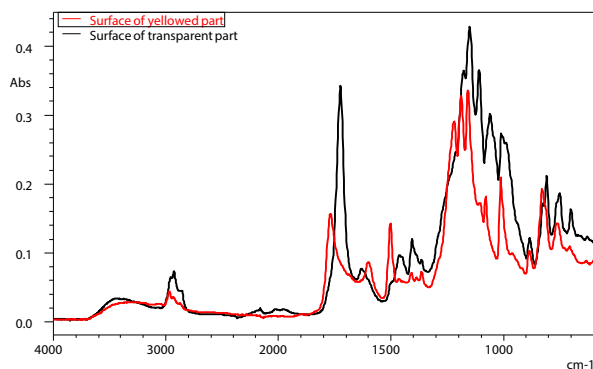
Fig. 3 shows the overlay of the infrared spectra of the transparent part and the yellowed part obtained by Plastic Analyzer.

Fig. 3 Infrared Spectra of Headlight Cover
(Black Line: Transparent Part, Red Line: Yellowed Part)

Comparing the transparent part and the yellowed part, the transparent part appears to be the spectral shape of the yellowed part + some other substance. First, therefore, a search of the yellowed part was conducted. Fig. 4 shows the obtained search result.

Here, the weak absorption at around 3400 cm⁻¹ seen in common in both the transparent part and the yellowed part is thought to be absorption due to O-H stretching vibration caused by oxidative degradation by sunlight (i.e., UV).

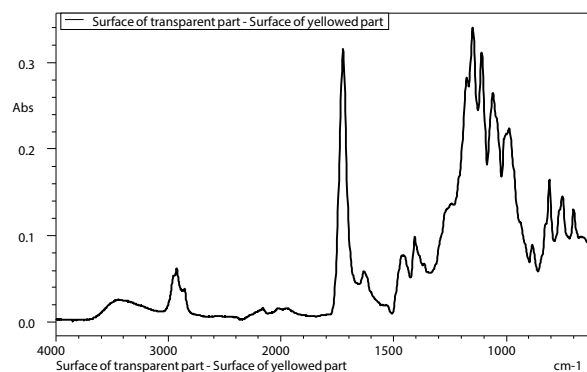
Next, in order to investigate other components of the transparent part, the difference spectrum of the transparent part and the yellowed part was calculated, and a search of the obtained difference spectrum was conducted. Fig. 5 shows the obtained difference spectrum, and Fig. 6 shows the search result.

Fig. 5 Difference Spectrum of Transparent Part - Yellowed Part

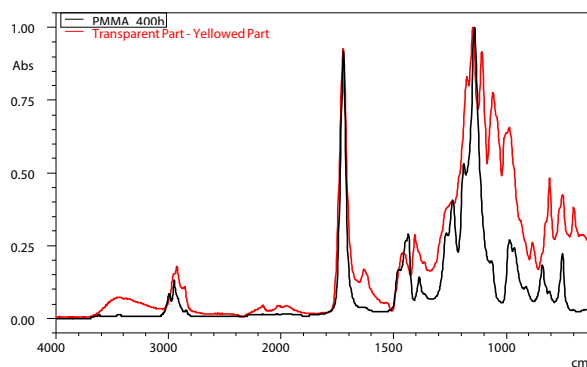
Fig. 6 Search Result of Transparent Part - Yellowed Part

From Fig. 6, a hit was obtained for polymethylmethacrylate (PMMA), which is registered in the UV-damaged plastics library. PC is frequently used in headlight covers because it has high mechanical strength and is resistant to fragmentation when cracked, but conversely, it is known to have poor resistance to UV. Since PMMA is essentially unaffected by UV, it is assumed that this PMMA was used as a coating material to prevent UV damage of the PC headlight cover.

1. The main component of both the transparent part and the yellowed part is PC.
2. Because O-H stretching vibration was confirmed from the infrared spectrum of the transparent part, deterioration had also proceeded in that part, although not to the point of discoloration.
3. Deteriorated PMMA was detected from the surface of the transparent part, and seems to have originated from a coating material used to prevent deterioration of the PC.
4. PMMA was not detected from the surface of the yellowed part. Because deterioration of the yellowed part had progressed further than in the transparent part, it is thought that the coating had peeled off in the yellowed part.
