**Analysis of Food Contaminants by EDX and FTIR
– Dental Materials –**

This article introduces an example of an analysis of a human tooth and various dental restorative materials that were presented to a food factory as contaminants by using EDX and FTIR.

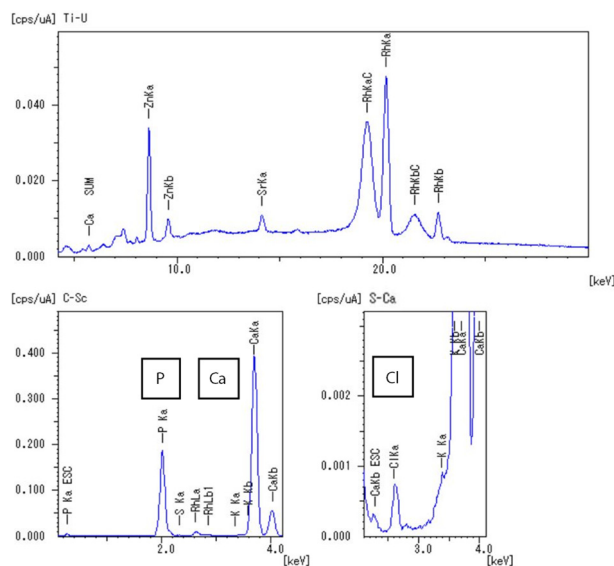
Fig. 1 Photograph of Contaminant (The Yellow Circle is the X-ray Irradiation Range: 1 mmφ)

Fig. 1 shows a photograph of the contaminant, and Fig. 2 shows the results of a ⁶³C-⁹²U qualitative and quantitative analysis by EDX. Ca and P, which are the main components of teeth, could be confirmed. Although the element composition is similar to that of bone, the smaller content of Sr is a distinctive feature of teeth. Fig. 3 shows the results of a qualitative analysis by FTIR. Because the contaminant had a distorted shape and was extremely hard, a small amount of the sample was scraped off and a microscopic transmission measurement was conducted while holding sample in a diamond cell. The main component is calcium phosphate, and peaks originating from proteins can also be confirmed. The proteins are considered to be deposits on the tooth surface. When an adhering deposit exists, the sample is cleaned with water or ethanol, dried, and then measured. However, care is required, as there is a risk of losing the contaminant.

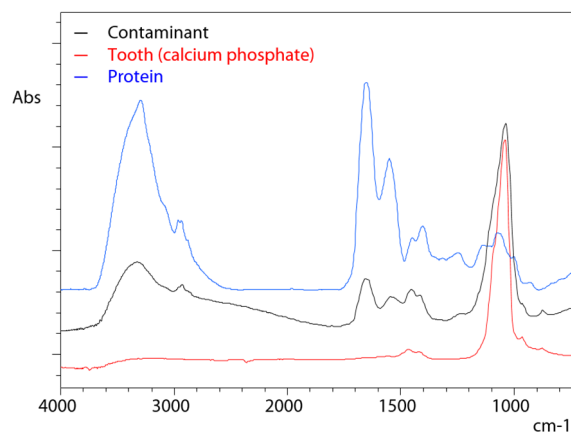
Element	Ca	P	Cl	Zn
Quantitative value (%)	70.99	27.23	1.21	0.21
Element	K	S	Sr	
Quantitative value (%)	0.18	0.16	0.019

Fig. 2 Qualitative and Quantitative Analysis Results: EDX

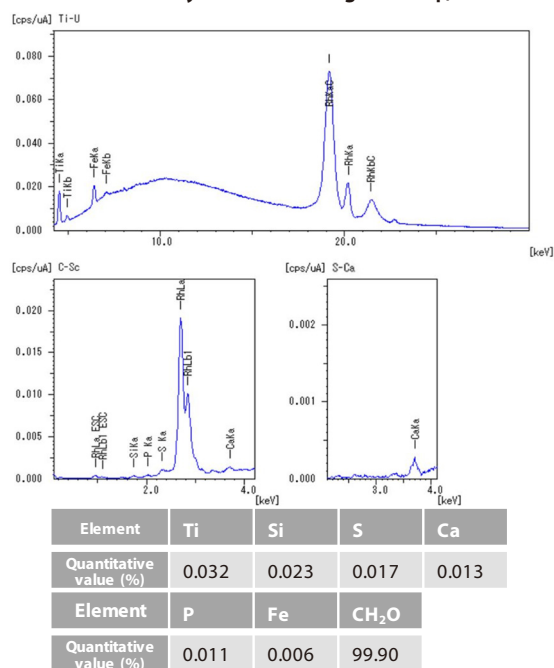
Fig. 4 Photograph of Contaminant (The Yellow Circle is the X-ray Irradiation Range: 1 mmφ)

Fig. 4 shows a photograph of the contaminant, and Fig. 5 shows the results of a ^{63}C - ^{92}U qualitative and quantitative analysis by EDX. Because the main component is an organic material, a quantitative calculation was done assuming the balance is CH_2O . Fig. 6 shows the results of a qualitative analysis by FTIR. A small amount of the sample was scraped off and a microscopic transmission measurement was conducted while holding sample in a diamond cell. As the result of a library search, hits were obtained for the spectra of polymethyl methacrylate (PMMA) and polyethyl methacrylate (PEMA). Based on these results, the contaminant is considered to be an artificial tooth (composite resin).

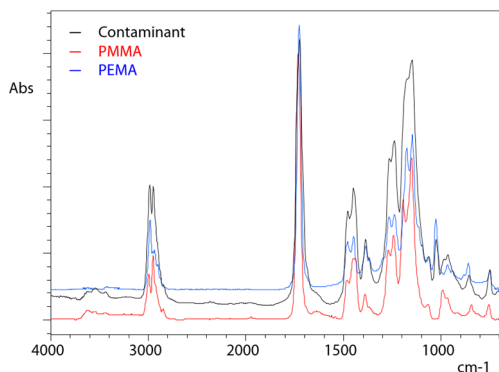
Fig. 5 Qualitative and Quantitative Analysis Results: EDX

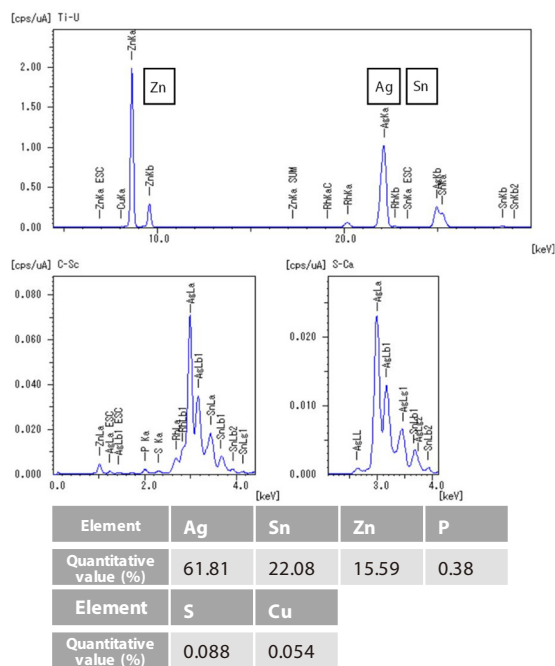
Fig. 7 Photograph of Contaminant (The Yellow Circle is the X-ray Irradiation Range: 1 mmφ)

Fig. 7 shows a photograph of the contaminant, and Fig. 8 shows the results of a ^{63}C - ^{92}U qualitative and quantitative analysis by EDX. The main components are Ag, Sn, and Zn. No significant peaks were detected in the FTIR analysis. Based on these results, the contaminant is thought to be an artificial tooth (metal tooth filling = silver crown).
