# Application News

## No. A499

## Confirmation of Raw Material Quality -Dealing with "Silent Change" Counterfeiting-

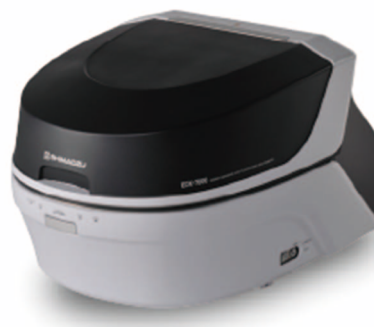
Fig. 1 EDX-7000 Energy Dispersive X-Ray Fluorescence Spectrometer

In this article, we use samples that may have been subject to a "silent change" (hereafter called "silent change" product) and introduce case analyses that confirm such changes using energy dispersive X-ray fluorescence spectrometry (EDX) (Fig. 1) and FTIR infrared spectrophotometry (Fig. 2).

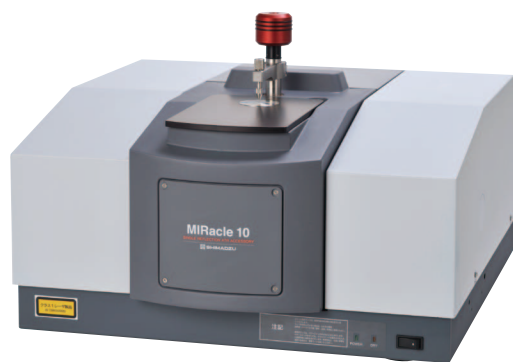
Fig. 2 IRAffinity-1S with MIRacle 10 Single-Reflection ATR Accessory

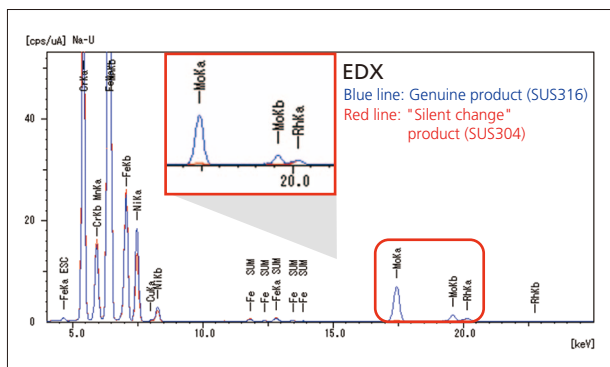
Fig. 3 shows that the molybdenum peak present in the genuine SUS316 is missing from the "silent change" product, which exhibits a profile identical to SUS304. This result shows the steel material in the "silent change" product has been replaced with a cheaper type.

Fig. 3 Results of EDX Analysis of SUS316 Genuine Product and "Silent Change" Product (SUS304)

Stainless steels are a special type of steel that are resistant to rust, that are created by adding various materials including chrome and nickel to iron. The stainless steel known as SUS316 has the composition 18Cr-12Ni-2.5Mo. It is created by adding molybdenum to SUS304 stainless steel, thereby improving its resistance to corrosion by sea water and other materials. We used EDX to analyze the stainless steel in a "silent change" product and in a genuine product. Analytical conditions are shown in Table 1, and EDX profiles are shown in Fig. 3.

Though it is impossible to tell by visual examination whether steel material has been changed, taking measurements by EDX provides confirmation of a "silent change."

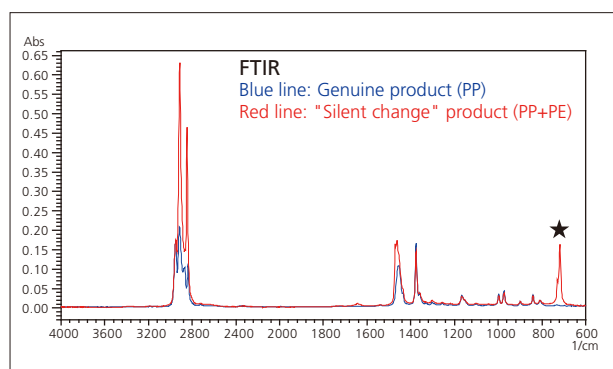
We used FTIR to analyze a genuine polypropylene (PP) product and a "silent change" product. Analytical conditions are shown in Table 2, and the spectra obtained are shown in Fig. 4. Fig. 4 shows a peak was detected in the "silent change" product originating from CH<sub>2</sub> rocking vibrations in the region of 718 cm<sup>-1</sup> (marked with a star). Spectral search confirmed that the "silent change" product contains polyethylene (PE) mixed in with PP.

Fig. 4 Results of FTIR Analysis of Genuine PP Product and "Silent Change" Product (PP+PE)

This result indicates that recycled plastic may have been mixed into the raw material.

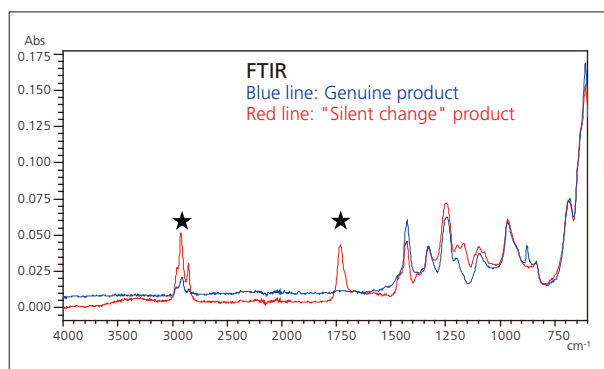
Fig. 6 also shows that apart from peaks originating from PVC, peaks originating from acrylic were detected in the region of 2900 cm<sup>-1</sup> and 1700 cm<sup>-1</sup> (marked with a star). This result shows the presence of a different material mixed in with the material in the "silent change" product.

Fig. 6 Results of FTIR Analysis of Genuine Plastic Product and "Silent Change" Plastic Product

We used EDX and FTIR to analyze a genuine polyvinyl chloride (PVC) product, and a "silent change" plastic product. The EDX analytical conditions are shown in Table 1 with corresponding profiles shown in Fig. 5, while FTIR analytical conditions are shown in Table 2 with corresponding spectra shown in Fig. 6.
